# Environmental Risk Assessment and Preventive Conservation Strategy for the Porch of the Glory, Santiago of Compostela Cathedral

**Abstract:** In the framework of the Santiago of Compostela Cathedral program, a multidisciplinary investigation of the porch of the glory was carried out between 2009 and 2011 to identify the main environmental risks and to develop a preventive conservation plan to be integrated in the general management strategy of the Cathedral. The study included historic and archival research, structural studies, mineralogical analyses, biological sampling, cleaning tests and microclimatic monitoring. The main weathering factors and the related damage processes were identified. Results have shown that the main responsible for the observed damage was the infiltration of rainwater through the roof, due to cracks in the structure of the Cathedral. Other environmental factors having a remarkable impact on the state of conservation of the polychrome and its substrate were the solar radiation, the thermo-hygrometric cycles, the particle deposition and the biological growth. Solutions were suggested to improve the environmental conditions, thus reducing further damage.

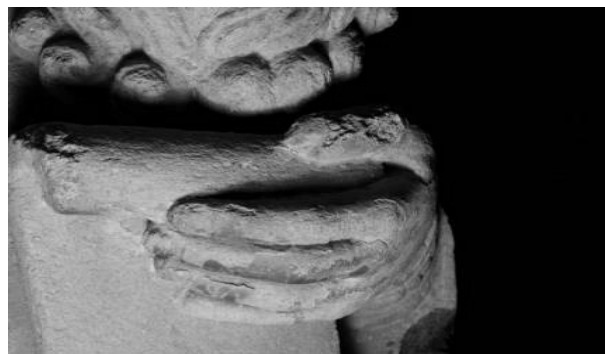
The porch was realized with three types of stones: marble, coarse-grained granite and fine-medium grained granite, with different mineralogical composition. Mortars and plasters are no more original materials but they belong to different ages and interventions. The stone materials and the plasters suffered of a quite large number of damage processes such as discoloration and stains caused by the remains of organisms, dust and dirt associated with percolation; efflorescences of nitrates and chlorides coming from percolations of water into the structure and deposition of marine aerosol; seritic alteration, arenization, pulverization, fractures and loss of fragments of material (Fig. 1) [6].

**Fig. 1** Deterioration processes affecting the porch of the glory: arenization due to seritic alteration of the granite.

The hygrometric values in the porch were generally quite high, with an annual average of 73% and maxima frequently reached in autumn and winter. For 55% of the total time (1 year) the relative humidity was higher than 65%, that is the reference value for the risk of biodeterioration [8]. The annual distribution of the hygrometric cycles, that may cause the dissolution/crystallization of the soluble salts, indicates that the cycles of 75% RH occurred for 6% of the total time (about 140 cycles in 1 year, with a rate of sampling of 3 h). 75% is about the equilibrium RH value of NaCl, responsible for the seritic alteration of the granite, a damage process mainly evident in the thin elements of the figures (fingers, curls) (Fig. 1) [9].

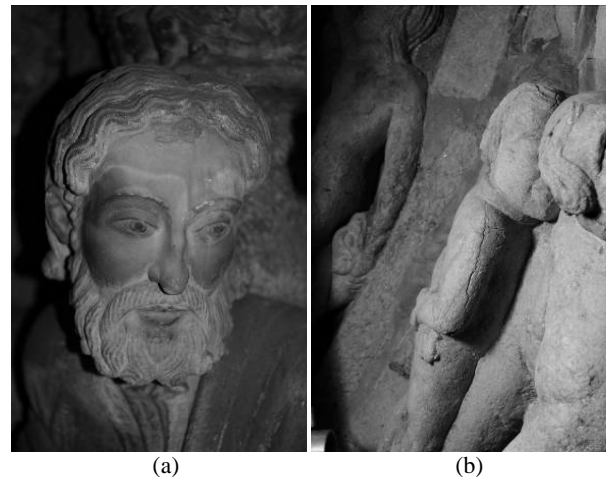
due to deposition of gypsum and oxalates were also observed, as well as sub-efflorescences and efflorescences of several saline species, such as sulfates, nitrates and chlorides (Fig. 2) [6].

**Fig. 2 Deterioration processes affecting the porch of the glory: (a) efflorescences on the edges of polychromy; (b) microfractures .**
