An Evaluation Method for the Potential of Old Apartment Buildings' Rehabilitation in Brazil

Abstract: The rehabilitation of older buildings for residential use that started in the last few decades of the 20th century has become recurrent in some Brazilian cities. In São Paulo, for instance, this subject is within the context of the revitalization of its downtown area with the reintroduction of residential occupancy in the region as a consequence of actions taken by public and private groups. However, older buildings were designed based on the technologies and regulations available in the past and applied to meet the lifestyles of the time of their construction. This paper presents a method for the analysis of older apartment buildings, diagnosing their strengths and limitations in adapting to both the new Brazilian regulatory and legislative requirements, and the contemporary domestic demands. Requirements, criteria and methods for evaluation were studied, and defined as well as procedures for the application of a method which allows for a physical and systematic analysis of old apartment buildings. It was found that the proposed method can be an important support tool at the mome

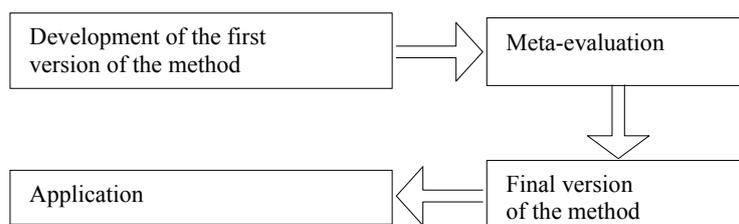
Fig. 2 Flowchart of the activities undertaken to organize the itinerary.

After the definition of the typology of the buildings to be evaluated by this method, the steps for its development were determined. The order of the tasks to be carried out was organized as in Fig. 2.

The explanation on the steps presented in Fig. 2 is shown below.
