Deterioration of Concrete by the Oxidation of Sulphide Minerals in the Aggregate

Josée Duchesne and Benoît Fournier

Abstract: Cases of degradation of concrete associated to iron sulphides in aggregates were recently recognized in the Trois-Rivières area, Canada. The aggregate used to produce concrete was an anorthositic gabbro containing various proportions of pyrite, pyrrhotite, chalcopyrite and pentlandite. Quantitative microanalysis on sulphide minerals show that pyrrhotite contains small amount of Ni, Co, Cu and As substituting for Fe in the mineral structure. Considering element substitution, x value in the chemical formula ($Fe_{1-x}S$) was calculated to 0.099 in the pyrrhotite studied. Petrographic examination of damaged concretes showed the presence of oxidized pyrrhotite. The observation of polished samples shows, in several cases, that the pyrite is intact while the pyrrhotite presents evident signs of oxidation. In the presence of water and oxygen, pyrrhotite oxidizes to form iron oxyhydroxides and sulphuric acid. The acid then reacts with the phases of the cement paste and provokes the formation of gypsum and ettringite. These minerals were observed by SEM-EDS (scanni

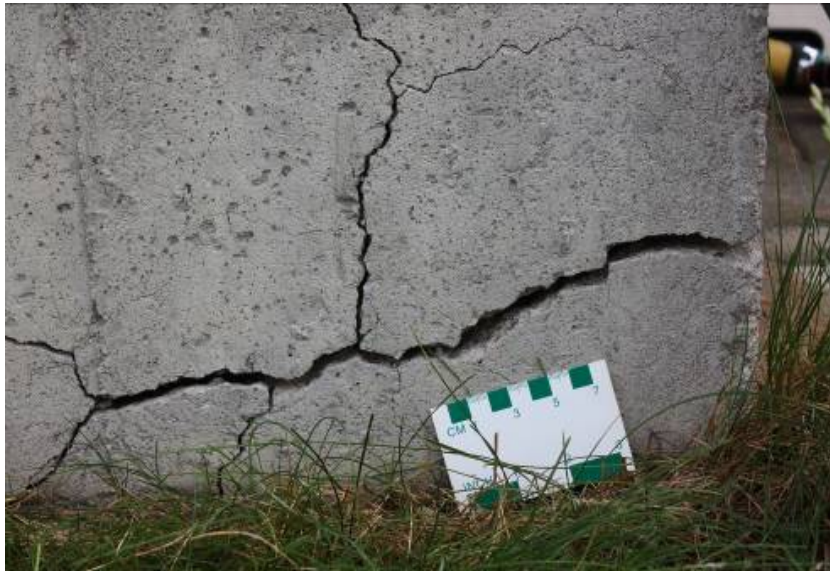
The deteriorated concrete displayed map cracking on the walls with open cracks more pronounced at the corners of the foundation walls (Fig. 1). Crack openings often reach up to 10 mm and values as high as 40 mm were reported. Major cracks are often concentrated next to rain gutters, which highlight the role of water or humidity in the reaction and deterioration processes. Yellowish coloration was often seen on the foundation walls. At some locations, iron oxide was visible in the open cracks. Deterioration causes an important breakdown of concrete structures and many foundations had to be replaced (Fig. 2). All the masonry and covering stones were first removed to lighten the structure. Houses were lifted up from their foundations and the later was demolished and replaced. The remediation cost was estimated to be close to the construction cost.

Fig. 1 Cracking in house concrete foundation.

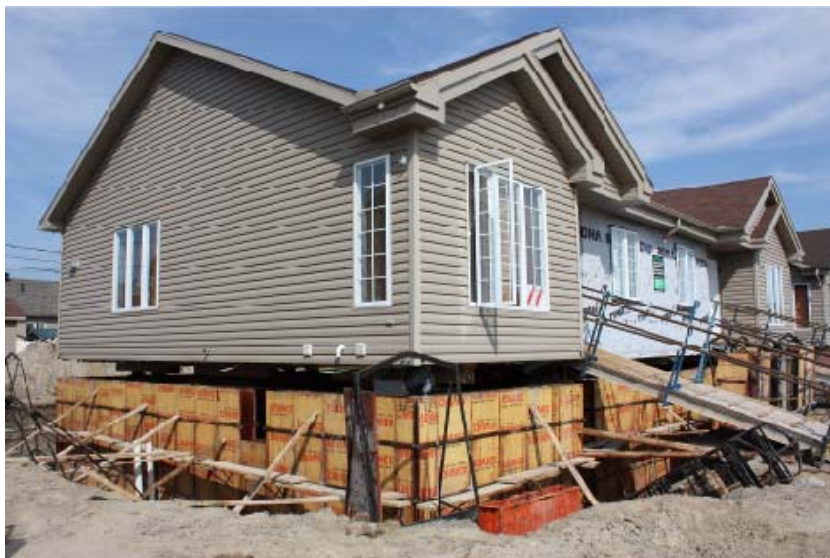
Fig. 2 Replacement of the concrete foundation walls.

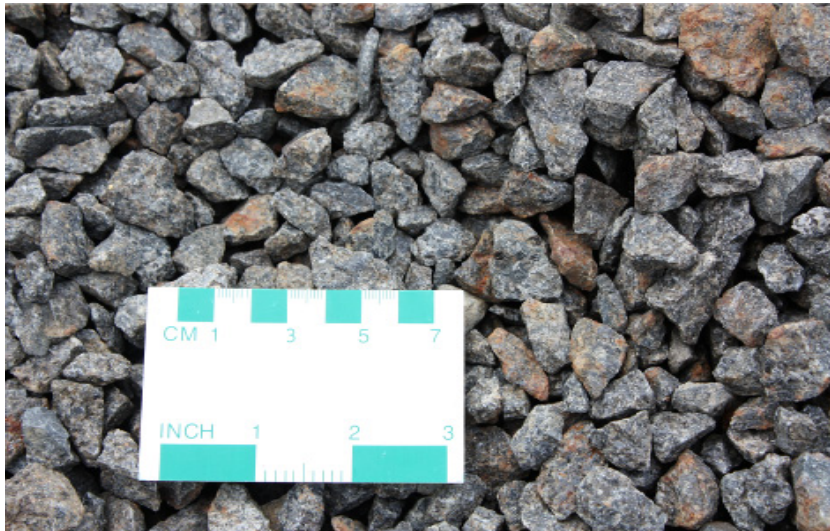
the same coarse aggregate containing a certain amount of sulphide minerals. The aggregate used to produce the deleterious concrete foundations was an anorthositic gabbro containing various proportions of sulphide minerals including pyrite, pyrrhotite, pentlandite ($(\text{Fe,Ni})_9\text{S}_8$) and chalcopyrite (CuFeS_2). Other constituting minerals consist mainly of calcic plagioclase feldspars ($\text{CaAl}_2\text{Si}_2\text{O}_8$), with lesser amounts of biotite ($\text{K}(\text{Mg,Fe})_3\text{AlSi}_3\text{O}_{10}(\text{F,OH})_2$) and pyroxene ($\text{XY}(\text{Si,Al})_2\text{O}_6$ —Ca-rich, Na-poor, high-Mg clinopyroxene) (Fig. 3).

Fig. 3 Crushed coarse aggregate (anorthositic gabbro).

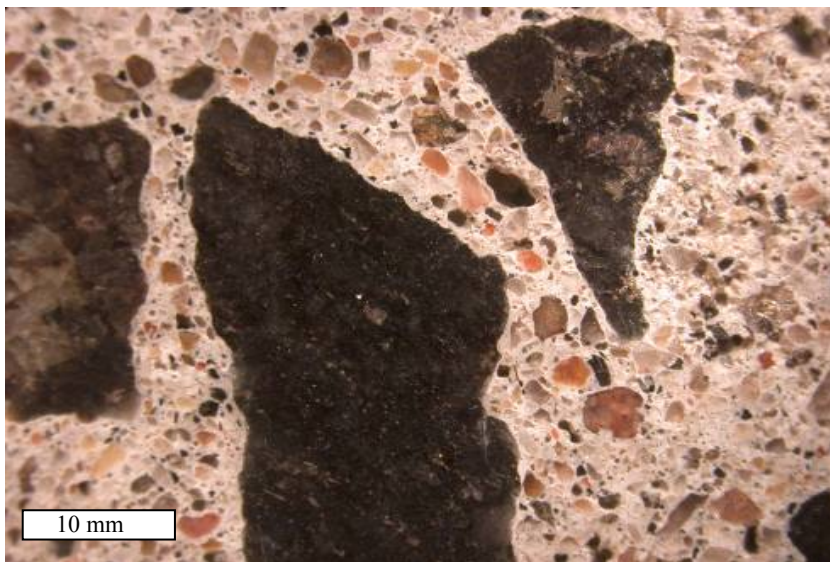
The pyrite and pyrrhotite contents vary significantly

from one particle to another and can reach up to 5%-7% of the total coarse aggregate volume (Fig. 4).

Fig. 4 Stereomicroscopic view of the anorthositic gabbro aggregate.

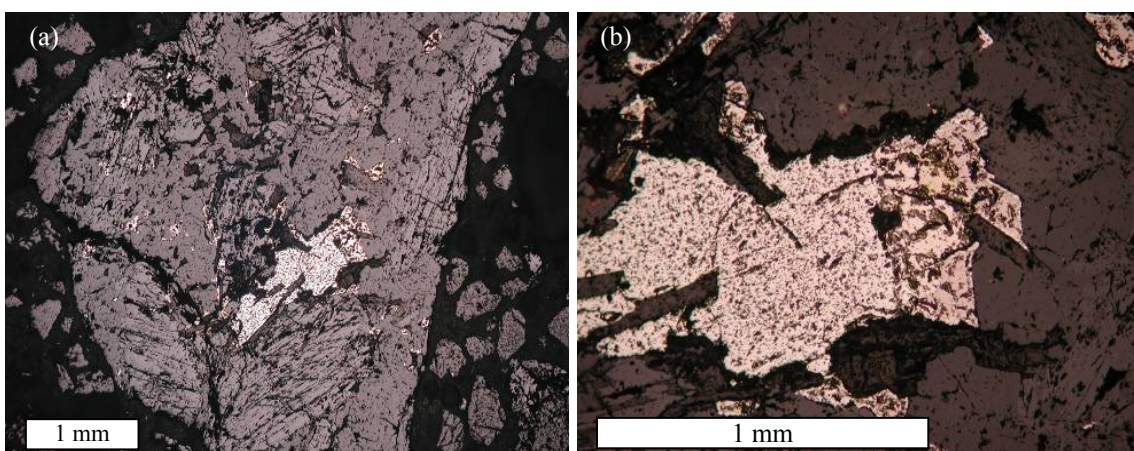
Fig. 5 presents reflected light microscopy images of the aggregate where iron sulphides, pyrite and

Fig. 5 Reflected polarized light views of iron sulphide minerals (Py = pyrite; Po= pyrrhotite).

pyrrhotite, were in close contact and well disseminated into silicate minerals. Very fine inclusion of opaque minerals can be seen throughout silicates. The observation of polished concrete samples confirms, in several cases, that the pyrite was intact while the pyrrhotite presented evident signs of oxidation.

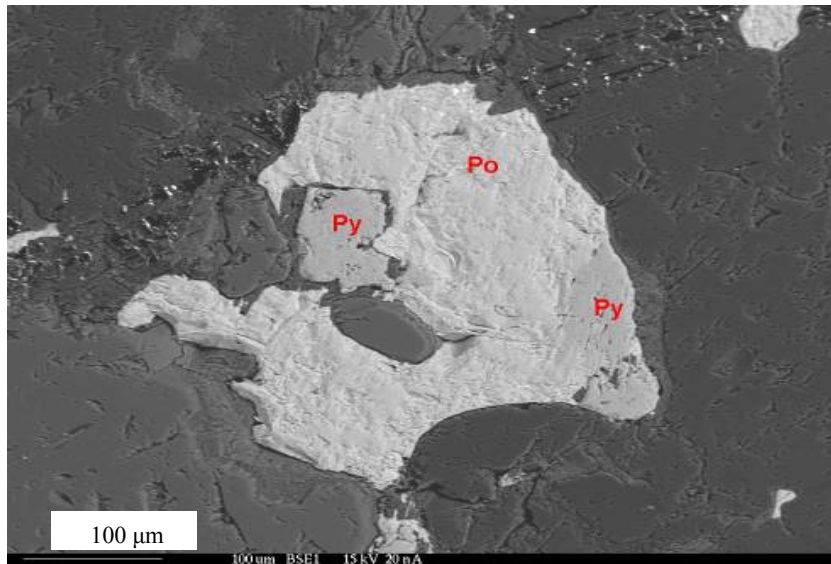
Fig. 6 presents BSE (back-scattered electron) images of the sulphide minerals taken by EPMA. Pyrite and pyrrhotite are seen in close contact with each other. Pyrrhotite grains appear with a lighter

color than pyrite on the BSE image due to its higher atomic density, with iron content higher and sulphur content lower than for pyrite.

Fig. 6 Back-scattered electron images of sulphides minerals within the anorthositic gabbro (Py = pyrite; Po = pyrrhotite).

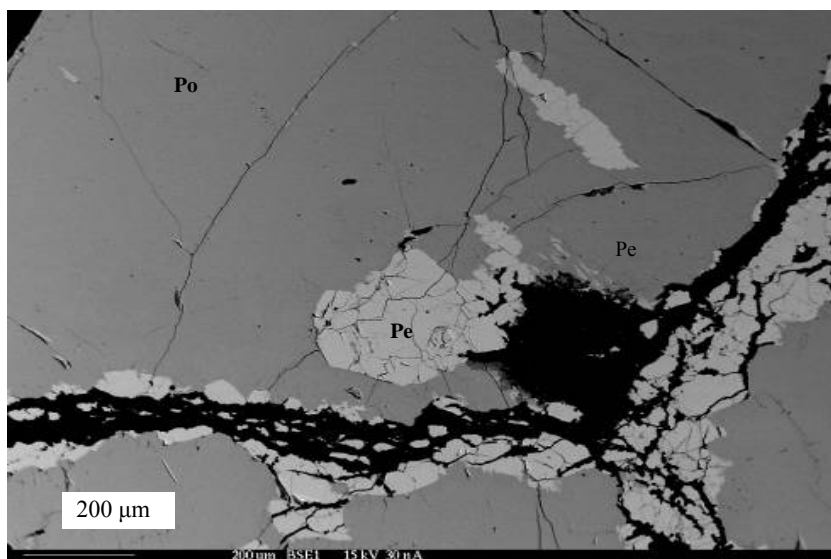
Fig. 7 presents a large grain of pyrrhotite with small inclusions of pentlandite which appear whiter compared to pyrrhotite in BSE image due to their high atomic density. Both minerals showed extended cracking. Black areas in the BSE images correspond to resin or light silicates. Few flame-textured pentlandite exsolved in pyrrhotite can be seen close to grain boundary or along main cracks. Pentlandite is by

Fig. 7 Back-scattered electron images of a pyrrhotite grain with pentlandite inclusions gabbro (Po = pyrrhotite; Pe = pentlandite).

far more cracked than pyrrhotite.

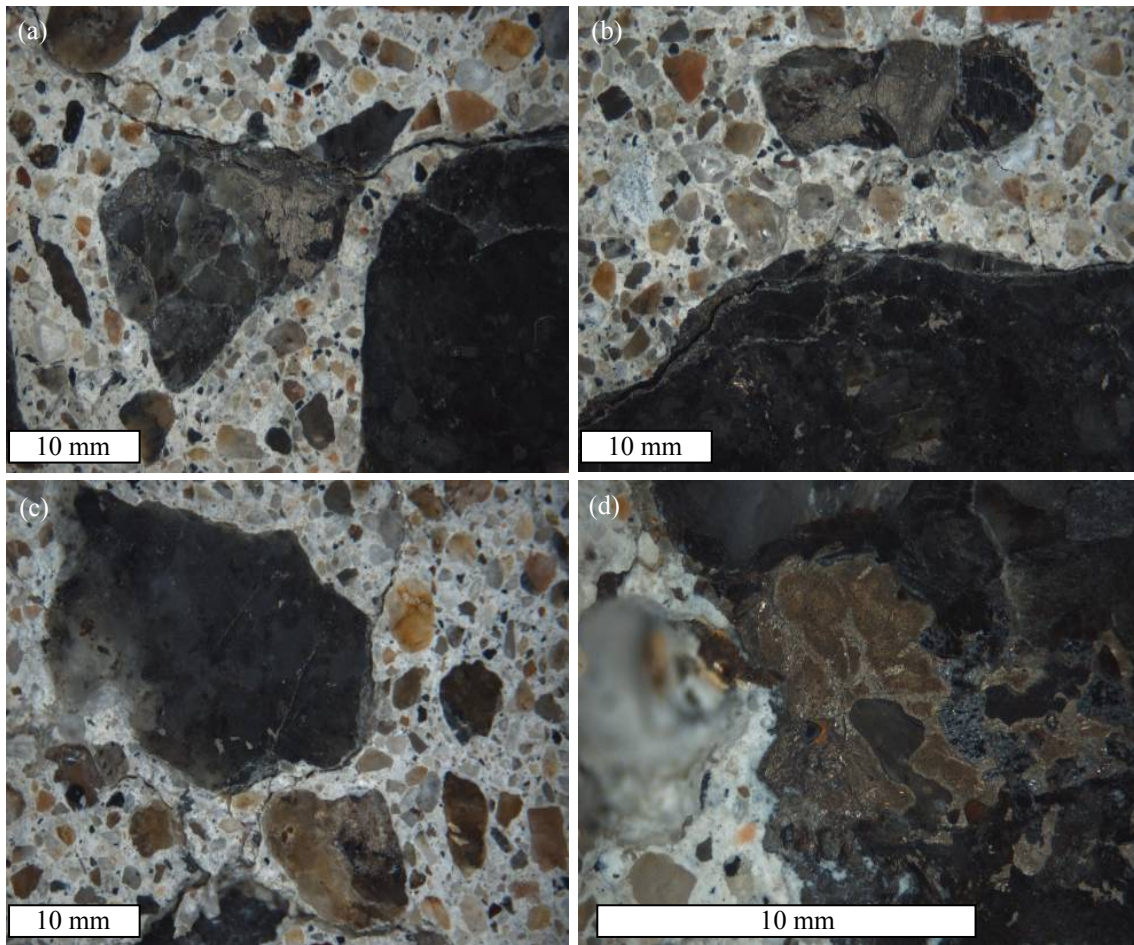
Fig. 8 presents stereomicroscopic views of the deteriorated concrete. In general, the cement paste is highly porous. This is not surprising considering the minimum compressive strength of 15 MPa required for plain concrete used in residential foundation applications. High water-cement ratio in the order of 0.7 is often used for this application. Most of the concrete samples were highly damaged, with important cracking being observed around or through

the aggregate particles and the cement pastes. The bond between the aggregate particles and the cement paste is very weak and some concrete samples can be easily broken in pieces by hand. They were often too damaged to be polished.

Some aggregate particles were extensively cracked, with some cracks extending from the aggregate particles to the surrounding cement paste (Figs. 8a and 8c). Most of the time, cracking occurred next to sulphide rich particles. Sometime, aggregate particles were mostly debonded, as in Figs. 8b and 8c and some particles were completely disintegrated. Fig. 8d is an enlargement showing rust (iron oxyhydroxide/iron sulphate) and a whitish powdery secondary product close to an air void.

Fig. 8 Stereomicroscopic views of deteriorated concretes.

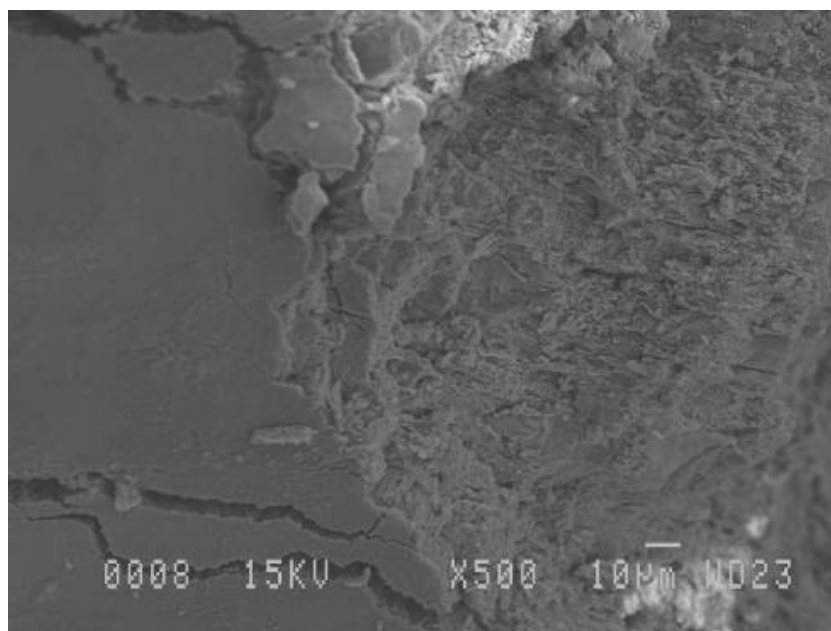
Fig. 9 shows a pyrrhotite grain on the left end side

Fig. 9 SEM images of deteriorated concrete with a pyrrhotite grain (left) in contact with iron oxyhydroxide (right).

of the micrograph, in close contact with an iron oxide, hydroxide or oxyhydroxide. The precise nature of the oxidation product can not be determined using EDXA because hydrogen is not detected. The EDXA signal (not presented) shows the x-ray lines of iron (Fe) and oxygen (O). Fig. 10 shows a layer of an iron sulphate next to a pyrrhotite grain. The EDXA signal shows the x-ray lines of iron (Fe), sulphur (S) and oxygen (O) (not presented). These secondary products are associated to the reaction of pyrrhotite. Fig. 11 exhibits a grain of gypsum (calcium sulphate dehydrate) with corresponding EDAX spectrum. SEM

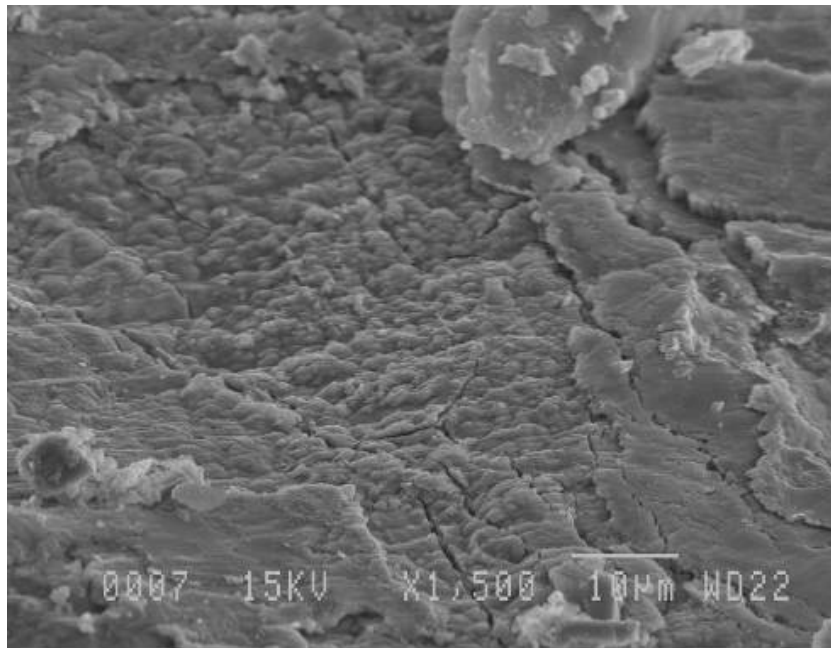
Fig. 10 SEM images of deteriorated concrete with iron sulphate close to pyrrhotite grain.

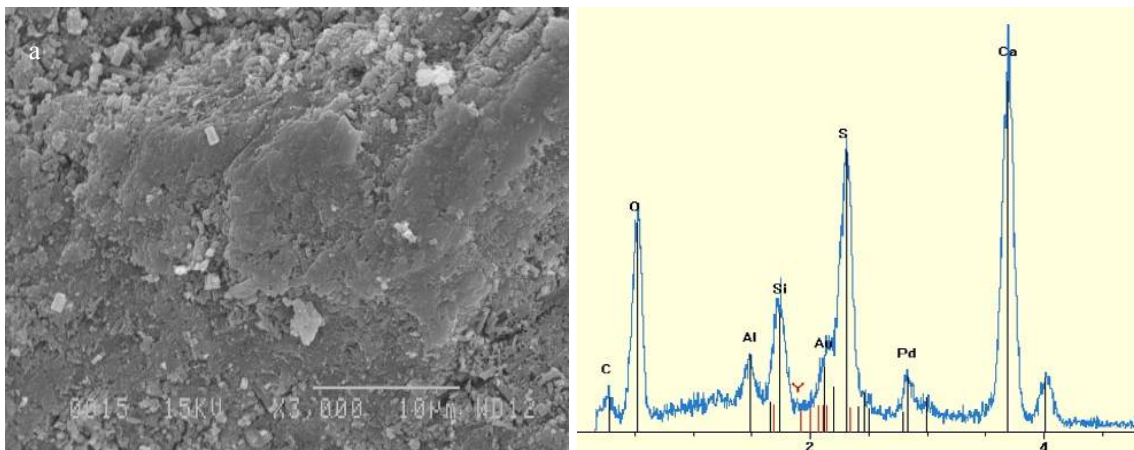
Fig. 11 SEM images + EDXA analysis of gypsum present in deteriorated concrete.
