# A Criterion for Tsunami Hazard Assessment at the Local Scale

**Abstract:** A criterion for tsunami hazard assessment at the local scale is proposed. It is based on travel times and water level height, calculated by the tsunami numerical model, combined with the existence or not of an easy evacuation path from the shoreline to safely high ground and evaluated by field survey. Furthermore, the 1755 Lisbon Tsunami is considered as the worst case scenario, allowing evaluating the impact of a similar scenario at Figueira da Foz municipality, Portugal. The results show that all the beaches are inundated and should be evacuated within an hour after the earthquake. Since there is safely high ground nearby most areas leading to a local tsunami hazard of “low”. However, the presence of unstable sand dunes that has been showing signs of collapsing at the south of Cova and Leirosa allowing the tsunami to penetrate inland, inundating the residential areas. For that reason, the local tsunami hazard is “moderate”. The other area which has “moderate” classification is Cabedelo, because it does not have any coastal protection from tsunami waves, and does not have easy access to the high ground.

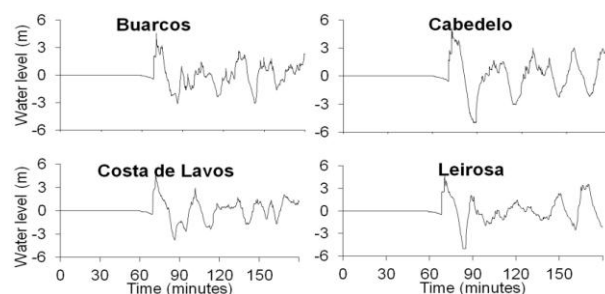
**Fig. 4 Water level waveforms at Figueira da Foz.**

The tsunami water level waveforms also show there are several waves, hitting the coastline (Fig. 4), being the first one and the highest. Still, even after three hours, the waves reach about 3 m high in Cabedelo and Leirosa.

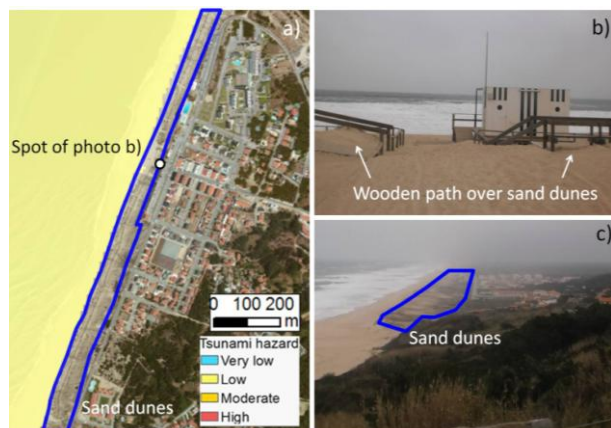
Fig. 9 Survey at Quiaios: a) Framework; b) Details at one of the beach accesses; c) Urban area overview.

The photos presented in Fig. 9 were taken on February 1, 2013 in Quiaios. The survey showed the area is located on high ground: The urban area is at 7.7 m high, having higher ground nearby; the sand dunes reach about 10 m high, which provides a natural barrier to the ocean waves (Fig. 9c). Furthermore, the survey showed there are several easy beach accesses to high ground (Fig. 9b). Still, if a tsunami occurs, people should evacuate the beach because that area is completely inundated with “low” TH. Therefore the local TH is classified as “low”.

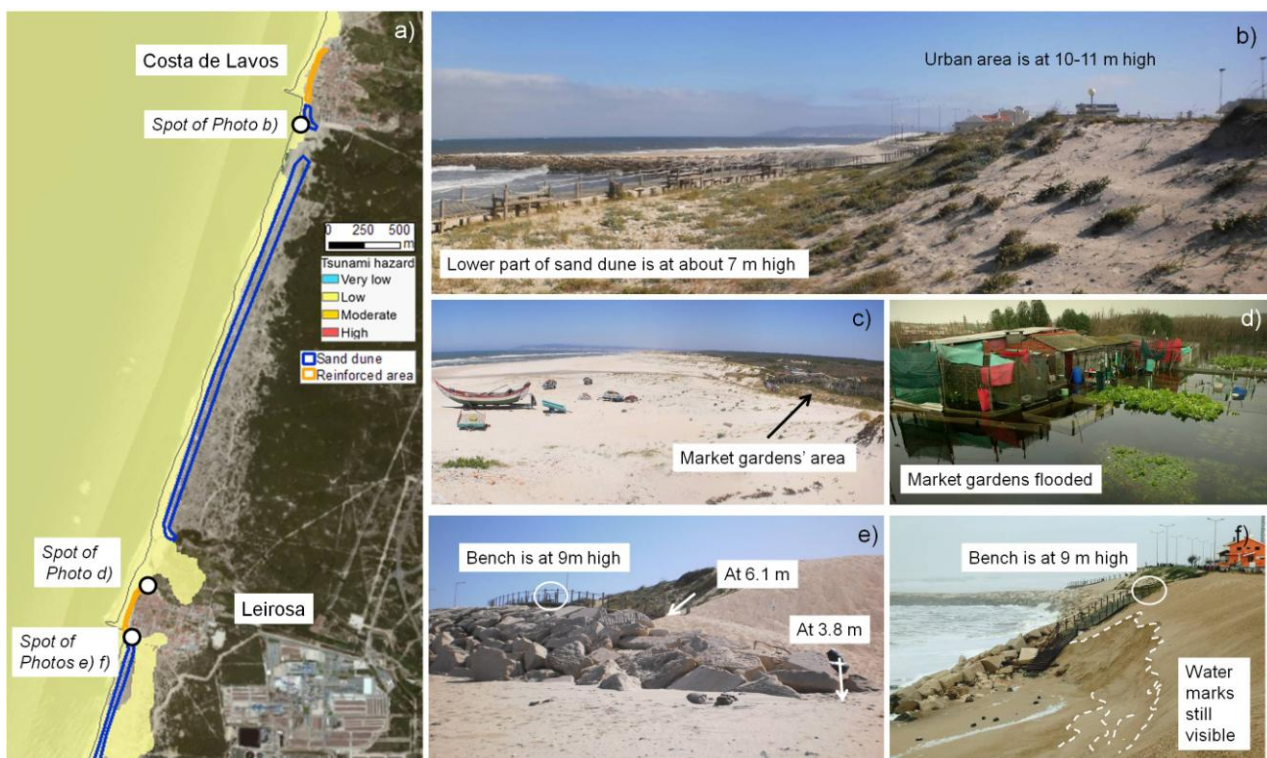
**Fig. 11** Survey at Costa de Lavos and Leirosa: a) Framework; b) Costa de Lavos; c) Survey at the north of Leirosa; d) Photo taken by Pedro A. Cruz [13] at the garden markets, north of Leirosa; e) Survey at the south of Leirosa; f) Photo taken by Pedro A. Cruz [13], south of Leirosa.

Details about Costa de Lavos and Leirosa are presented in Fig. 11. The field survey conducted at Costa de Lavos showed the urban area was located on high ground, at 10-11 m high, being protected by a reinforced sand dune. The photo presented in Fig. 11b was taken on June 14, 2013, and it shows the south area of Costa de Lavos where a natural sand dune stands stable. The lower part of the sand dune is at

about 7 m high, and the top of it is at about 11 m high. Thus, validating the numerical model results which show the inundation area is restricted to the beach. The survey also showed there are several wooden paths allowing an easy access to safely high ground. Therefore the local TH is "low".

The field survey at Leirosa shows the urban area is located at 6-11 m high, protected by a reinforced sand dune, with easy access to high ground, like in Costa de Lavos. However, the north and south areas are quite vulnerable. A photo of the north area taken on June 1, 2013 (Fig. 11c) shows the fishermen keep their fishing boats and equipment on high ground, at about 11 m high. However, the market gardens are located at about 6 m high, do not have any coastal protection, and are flooded by the 2014 Tsunami [39], as presented in Fig. 11d, destroying the vegetables' plantations [13]. These results validate the tsunami numerical model which show the market gardens are inundated, and therefore, vulnerable to tsunamis. On

the other hand, the south of Leirosa is protected by a 10 m high sand dune, as shown by the photo taken on June 14, 2013 (Fig. 11e). However, the area was also affected by the 2014 Tsunami where several boulders were dragged and the lower parts of the wooden side walk were destroyed (Fig. 11f). Although the urban area was not flooded, the presence of several water marks showed the sand dune could easily collapse if hit by a tsunami. Thus, like in the south of Cova, if no further intervention is conducted on the area, the sand dune will not stand, allowing the urban area to be inundated by the tsunami till 280 m inland, as calculated by the tsunami numerical model. As a consequence, the local TH in Leirosa is “moderate”.
